LEVEL 2 REPLACEMENT RESERVE REPORT FY 2023 PLANTATION LAKES

REPLACEMENT RESERVE REPORT

PLANTATION LAKES

April 14, 2022

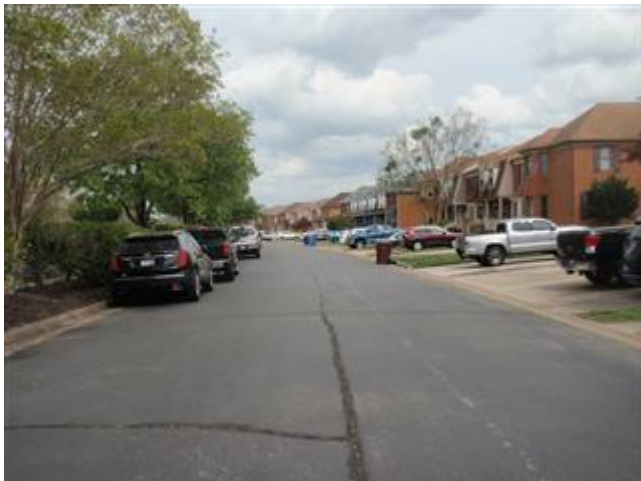
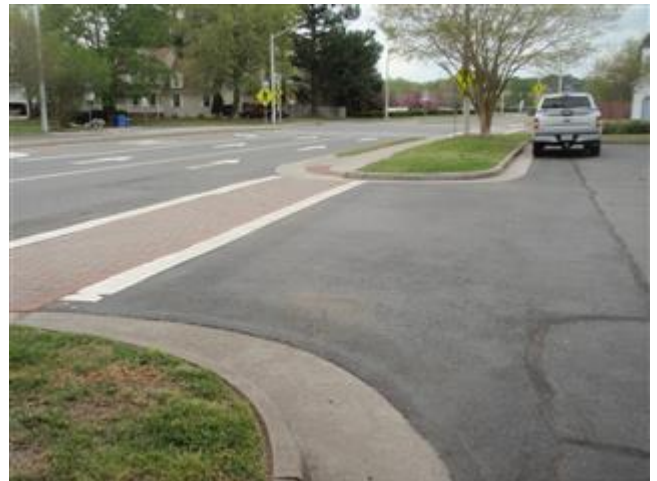
Asphalt Pavement. The Association is responsible for the two feeder roads parallel to Volvo Parkway at the townhomes within the community; other roadways are maintained by the City. The Association maintains an inventory of 88,676 square feet of asphalt pavement.

The roadways do receive light duty traffic, but the ingress and egress areas display considerable wear and deterioration. Despite seal coating and partial crack filling, the age of the asphalt is well past the normal economic life and a full overlay with partial milling should be anticipated within one to two years.

- **Crack Repair.** All cracks should be repaired with an appropriate compound to prevent water infiltration through the asphalt into the base. This repair should be done annually. Crack repair is normally considered a maintenance activity and is not funded from Reserves. Areas of extensive cracking or deterioration that cannot be made watertight should be cut out and patched.

- **Seal Coating.** The asphalt should be seal coated every 5 to 7 years. For this maintenance activity to be effective in extending the life of the asphalt, cleaning and crack repair should be performed first. The pricing used is based on recent contracts for a 2-inch overlay, which reflects the current local market for this work.

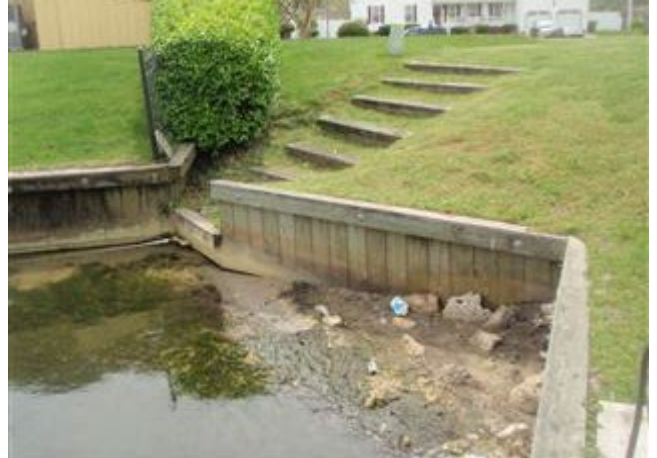
Bulkhead at Kayak Launch Area. The common area #1 near the intersection of Volvo Parkway and Plantation Lakes Circle consists of timber access steps and a small length of bulkhead. The previous timber access steps are in marginal condition. Bulkhead was previously reported to have been replaced in 2006 and remains in fair overall condition. Water levels and erosion should be monitored to ensure undermining, or overturning does not occur. The launch area should be kept clean of trash and other debris to ensure safety for users. Cleaning of sand is not practical but additional sand can be added periodically for the benefit of users if warranted by Owner interest.

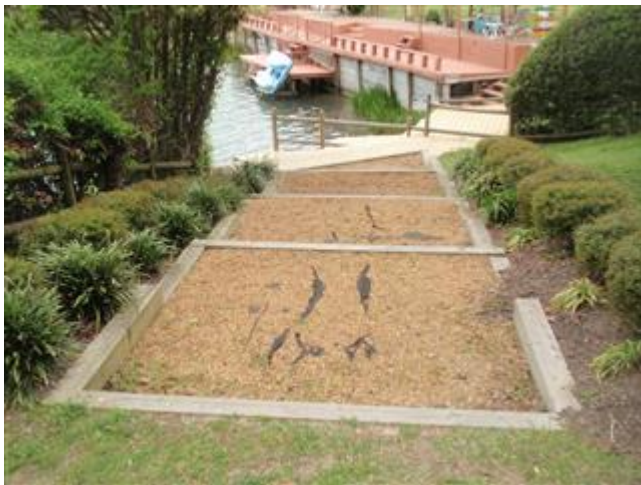
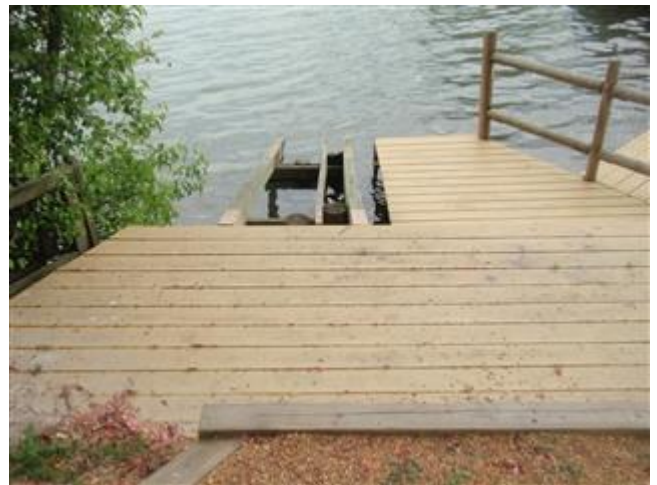
Picnic Area, Bulkhead, and Recreational Dock. The Common Area #2 along Plantation Lakes Circle consists of a shaded grass picnic area with a brick masonry barbecue grill, a small length of timber bulkhead with a recreational dock of pressure treated lumber. The bulkhead is believed to be in good condition and should last its full useful life. The decking and kayak launch appear to have been refurbished or partially replaced several years ago. The timber steps were replaced about 6 years ago and are in good condition. The gravel walk surfacing at the steps shows displacement and possible erosion that has exposed the filter fabric underlayment. This should be corrected as needed using operating funds.

The brick grill is in fair overall condition and as a long-lived component is excluded at the request of the Board. The signage and the bulletin board kiosk are excluded as low-value items per the Board.

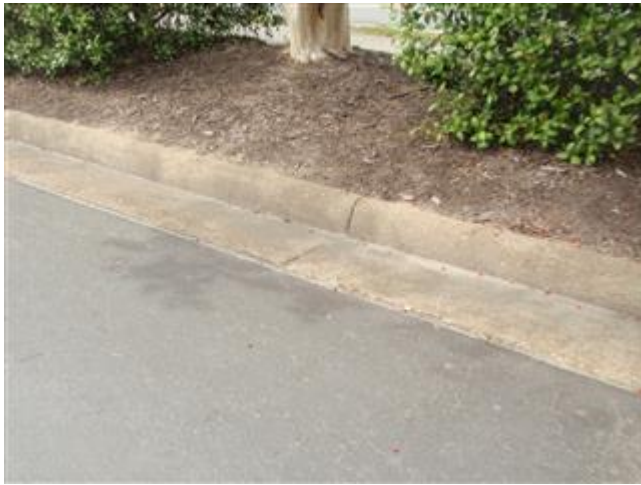
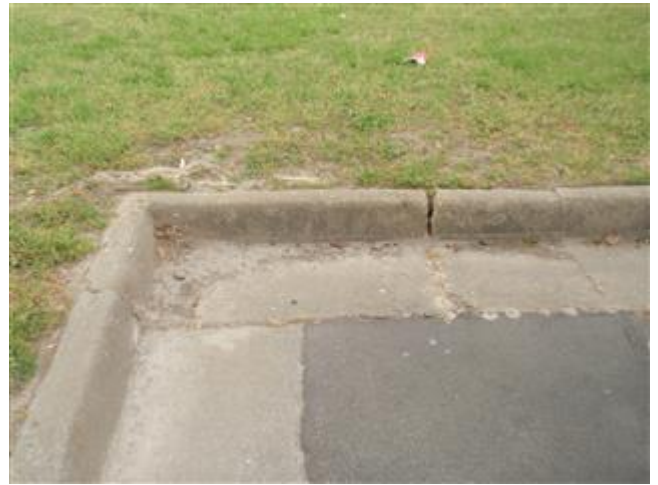
Concrete Work. The concrete work includes the community curbs, along the feeder roads serving the townhomes parallel to Volvo Parkway. The Association maintains an inventory of approximately 3,300 linear feet of concrete curb and gutter at the feeder roads. We typically model for curb replacement when the asphalt pavement is milled and overlaid. The overall condition of the concrete work is mixed with several isolated areas of general deterioration, including differential settlement, cracking, spalling, and scale.

- Trip hazard, ½ inch height difference.
- Severe cracking.
- Severe spalling and scale.
- Uneven riser heights on steps. Steps with risers in excess of 8¼ inches.

The Association intends to replace mailboxes within the next 12 months, and it is highly encouraged that the pads for the mailboxes be enlarged, and a portion of curb and gutter be removed to install an ADA compliant curb cut and a pad with a large enough turning radius to be fully accessible and to comply with the Fair Housing Act. None of the current mailbox locations are considered compliant and the mailbox replacement is an ideal opportunity to make them compliant.

Because it is highly unlikely that all of the concrete components will fail and require replacement in the period of the study, we have programmed funds for the replacement of these inventories and spread the funds over an extended timeframe to reflect the incremental nature of this work.

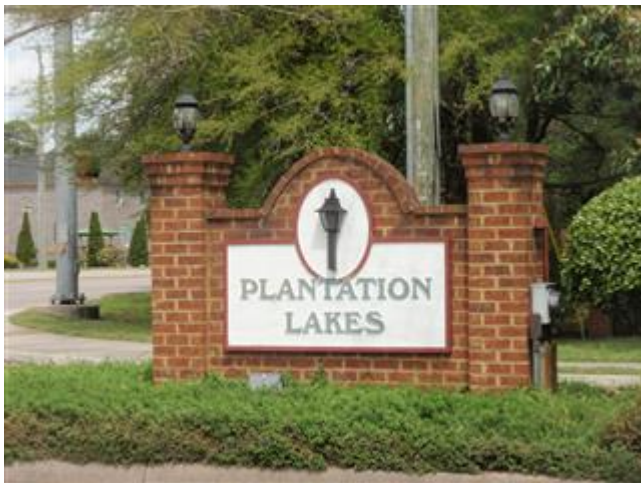
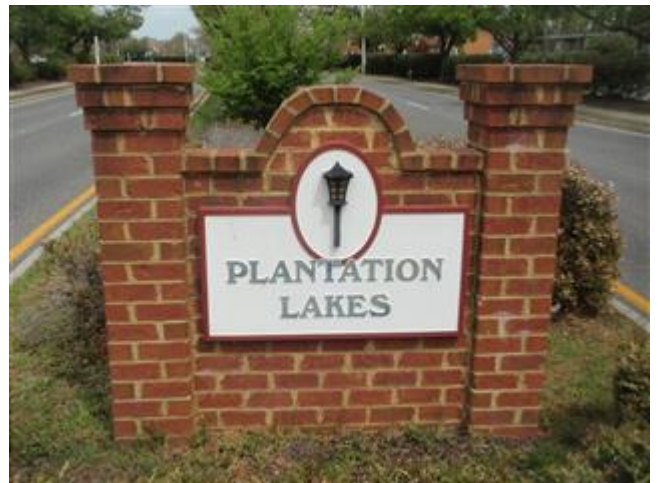
Entry Monument and Signage. The Association maintains three entry monuments. The main entrance at Plantation Lake Circle and Kempsville Road and two located in the median of Volvo Parkway. The monuments are made of brick masonry and are in good to fair overall condition, with no visible open masonry joints or loose and broken masonry units. The monument signage panels are acrylic or other synthetic material and in fair overall condition. These are expected to have a useful life of 10 to 15 years if not refurbished periodically. We have included funds for refurbishing as it can extend the life of the signs.

Full replacement of the brick monuments is excluded as a long-lived item. However, previous vehicle damage to the main sign has required substantial partial replacement in the past. We recommend repointing and replacement of defective areas of the masonry as needed and these should be examined annually. The Association may want to consider applying a coat of Siloxane or other appropriate breathable sealant to mitigate water penetration and further degradation of the masonry work. For additional information, please see the appropriate links on our web site at <http://mdareserves.com/resources/links/building-exterior>.

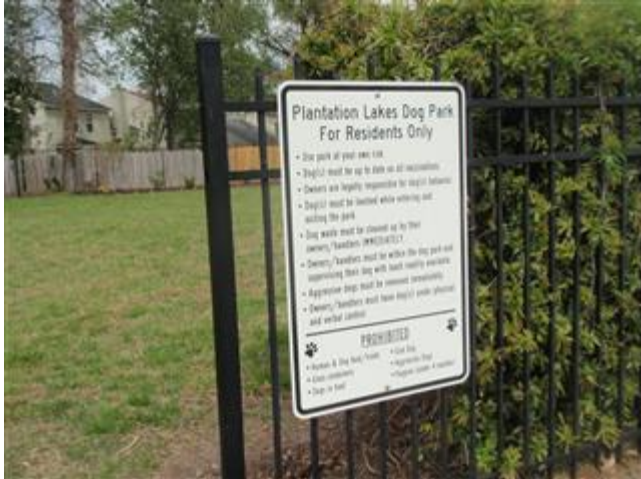
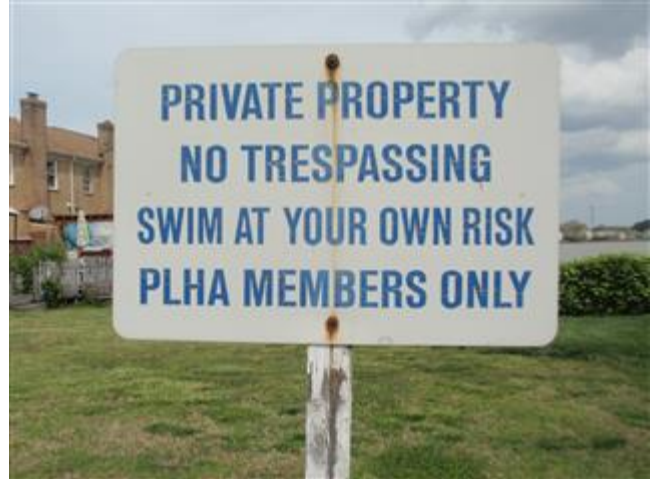
The bulletin board kiosks and the miscellaneous signage can be replaced as needed using operation funds, but we have included a small partial allowance for parking and traffic signage on the private roads and at the Common Areas around Lakes 1 and 2 as well as the new dog park.

Wood posts show a variety of age-related deterioration as well as damage around the base from grounds keeping.

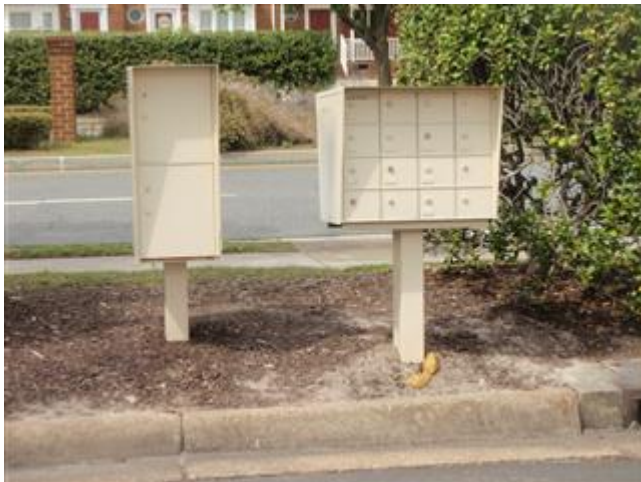
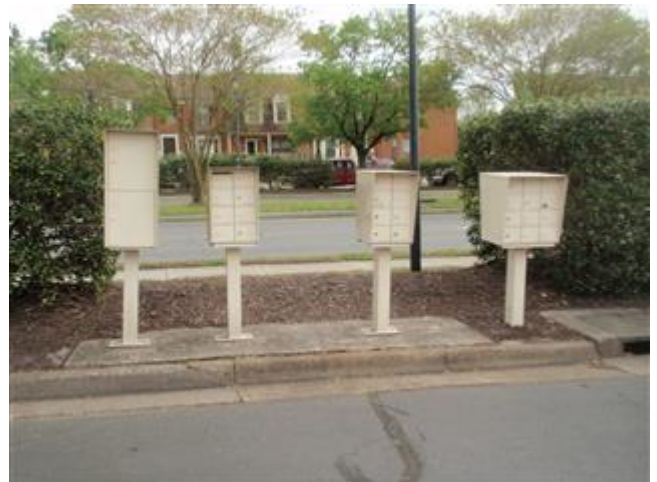
Mailboxes. The cluster mailboxes located throughout the community townhome areas are original and are in poor overall condition. The community has a series of cluster mailboxes for the townhouse type residences spaced intermittently along the Volvo Parkway feeder roads. The mailboxes were previously reported to have been powder coated in 2008 and the normal and remaining life was increased at that time to reflect this level of maintenance. However, the life of the boxes and pedestals are no longer capable of being extended by maintenance or repair. At least one box was reported to have fallen over from the corroded pedestal and base.

The Association indicates they intend to replace all mailboxes in 2022. No firm bids for replacement have been obtained yet. The budget cost used in the study assumes a labor cost of \$500 for each mailbox cluster.

See the recommendations for enlarging the concrete pads and providing handicap accessibility by replacing curb and gutter with an ADA ramp for each mail location.

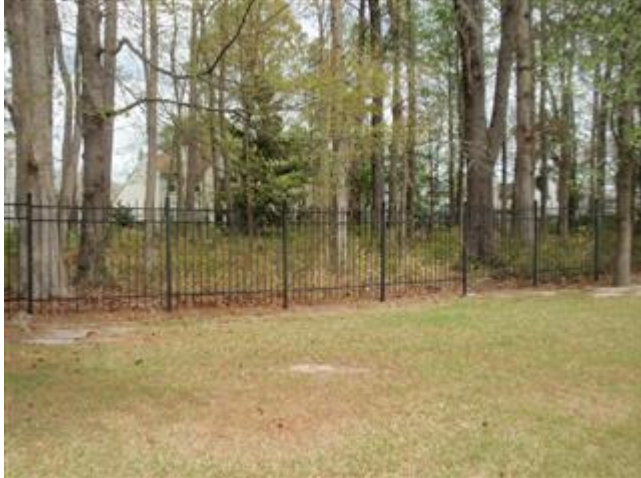
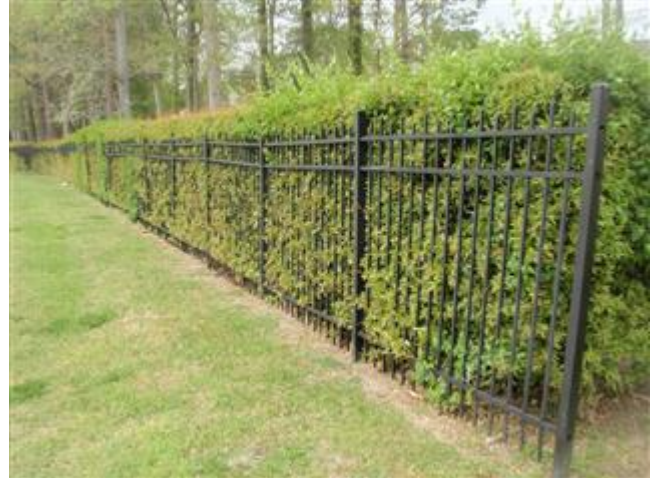
Ornamental Fencing. The Association maintains aluminum picket ornamental fencing that is in generally marginal to fair overall condition based primarily on age. This fence is located along the main entrance from Kempsville Road. Fencing systems have a large number of configurations and finishes and can usually be repaired as a maintenance activity by replacing individual components as they become damaged or weathered. Portions of the fence are largely obstructed from visual examination due to the hedge.

Previously damaged portions of the fence have been replaced and will be replaced as needed using operating funds. Protection from string machine damage during lawn maintenance can extend the useful life of some fence types. Protection from this type of damage is typically provided by applying herbicides around post bases or installing protective sheathing.

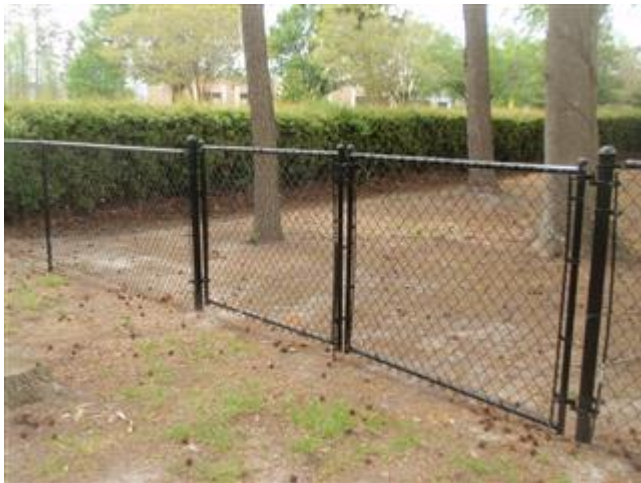
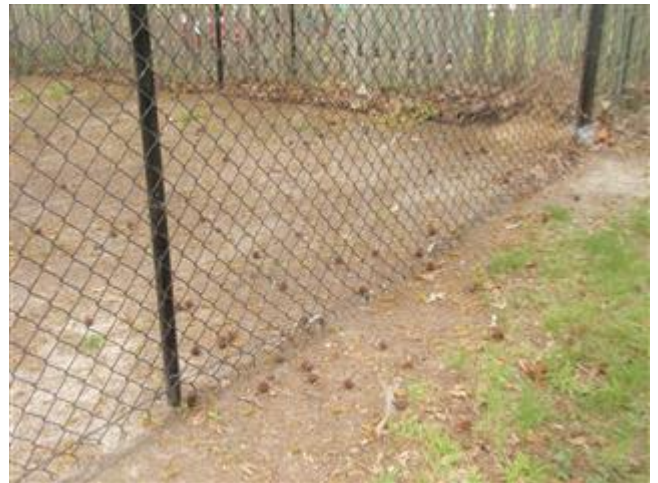
Chain Link Fencing. The Association maintains a 42-inch chain link fence around the dog park established in 2019-2020 adjacent to the Kempsville Road entrance. There is also a long perimeter of 6-foot tall chain link to enclose the green space and natural area on the recently acquired parcel. These new amenities were purchased as a capital improvement and are in very good overall condition. The total reported cost of the fence in 2019-20 is approximately \$22,240 and includes gates.

The fences are added to the inventory for this update. The 6-foot fence has multiple damaged sections from tree limbs. In addition to a full fence replacement in the future a partial allowance of 10% every 5 years is anticipated to replace the damage sections as they occur.

Protection from string machine damage during lawn maintenance can extend the useful life of some fence types. Protection from this type of damage is typically provided by applying herbicides around post bases or installing protective sheathing.

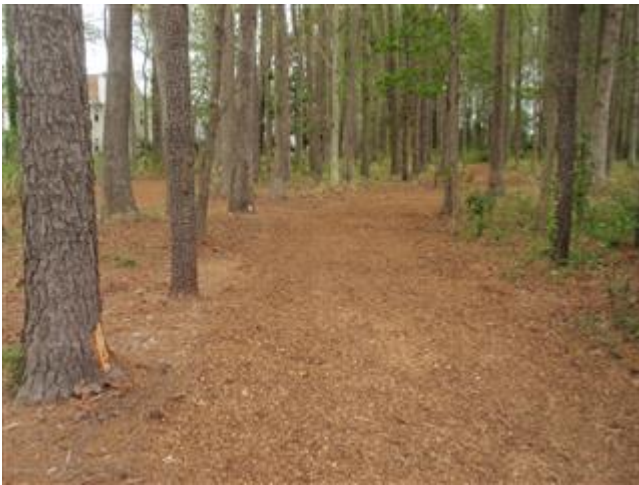
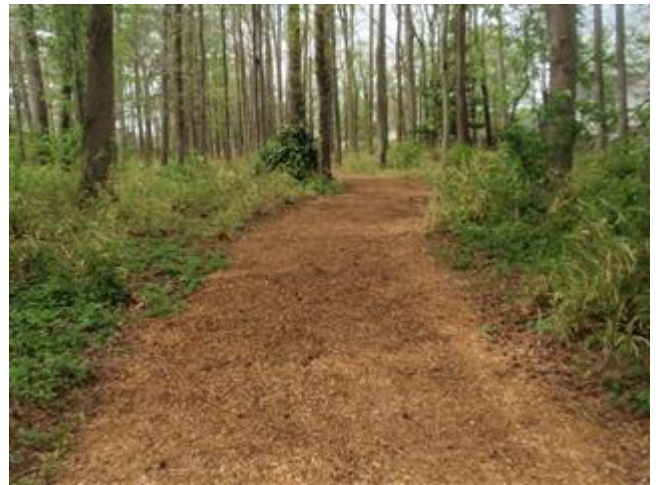
Nature Trail. The recently acquired parcel of land has a wooded area that has been partially cleared to create a walking path loop around the area. The path is on grade and has a wood mulch surface. The mulch will deteriorate over time through natural decomposition and the native vegetation will try to reclaim the space so a regular program of clearing and replenishment of the mulch is anticipated to be performed every 1-3 years.

Some surfaces of wood chips may be available from time to time from commercial tree companies. However, the large volume that will be needed and the equipment to place it will require some costs as either replacement reserves or operating funds.
