LEVEL 2 REPLACEMENT RESERVE REPORT FY 2023 PLANTATION LAKES

REPLACEMENT RESERVE REPORT

PLANTATION LAKES

April 14, 2022

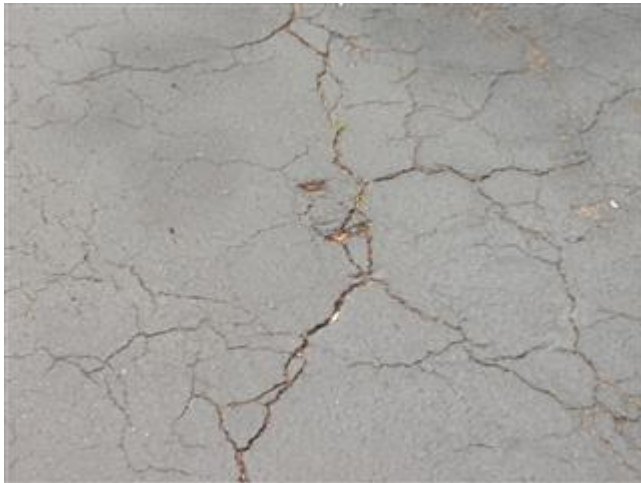
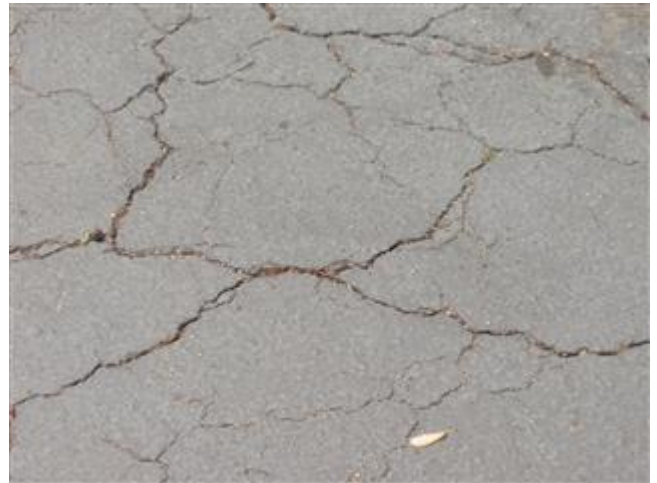
- **Crack Repair.** All cracks should be repaired with an appropriate compound to prevent water infiltration through the asphalt into the base. This repair should be done annually. Crack repair is normally considered a maintenance activity and is not funded from Reserves. Areas of extensive cracking or deterioration that cannot be made watertight should be cut out and patched.

- **Seal Coating.** The asphalt should be seal coated every 5 to 7 years. For this maintenance activity to be effective in extending the life of the asphalt, cleaning and crack repair should be performed first. The pricing used is based on recent contracts for a 2-inch overlay, which reflects the current local market for this work.

For seal coating, several different products are available. The older, more traditional seal coating products are simply paints. They coat the surface of the asphalt, and they are minimally effective. However, the newer coating materials, such as those from Total Asphalt Management, Asphalt Restoration Technologies, Inc., and others, are penetrating. They are engineered, so to speak, to 'remoisturize' the pavement. Asphalt pavement is intended to be flexible. Over time, the volatile chemicals in the pavement dry, the pavement becomes brittle, and degradation follows in the forms of cracking and potholes. Remoisturizing the pavement can return its flexibility and extend the life of the pavement.
